Tire Warranty Conditions

COVERED Warranty Conditions	NOT COVERED Warranty Conditions
<p>TREAD:</p> <ul style="list-style-type: none"> • Tread Separation <p>SIDEWALL:</p> <ul style="list-style-type: none"> • Shoulder Cracking • Sidewall Separation • Spread Ply <p>BEAD:</p> <ul style="list-style-type: none"> • Circumferential Bead Cracking • Migrating Bead Wire • Bead Area Separation <p>LINER:</p> <ul style="list-style-type: none"> • Trapped Air in Liner over 0.25 inch • Liner Crack • Thin Liner • Open Liner Splice <p>OTHER:</p> <ul style="list-style-type: none"> • Light/thin Rubber • Foreign Material • Vibration before the first 2/32nd of treadwear • Weather Checking (2 years from date of purchase) 	<p>ROAD HAZARDS:</p> <ul style="list-style-type: none"> • Sidewall Cut • Curbing (Sidewall or Shoulder) • Bubble in Sidewall • Puncture Beyond Repairable Limits • Impact Break in Liner • Impact Break Across Tread • Cut Tread • Ran Underinflated to Destruction <p>IRREGULAR WEAR:</p> <ul style="list-style-type: none"> • Heel and Toe Wear • Diagonal Wipe Wear • Depressed Rib Wear • Erosion Wear • Fast Centerline Wear • 360* One-Side Shoulder Wear • 360* Both Side Shoulder Wear • Hi-low Lug

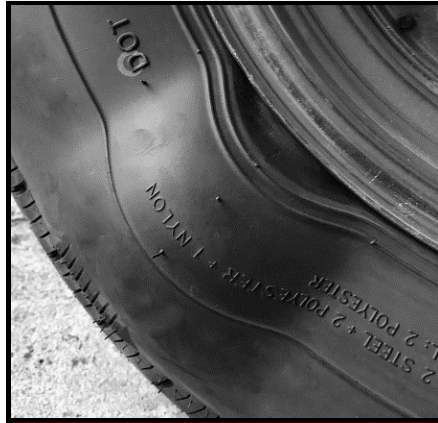
Impact Break - Sidewall

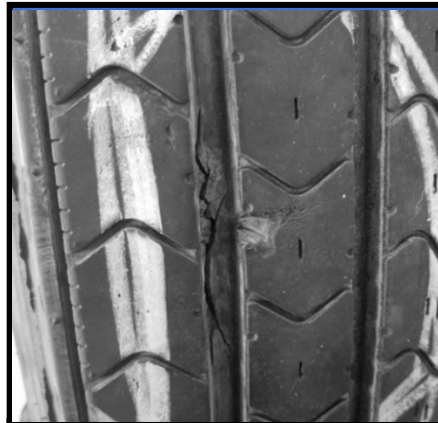
Cut Sidewall or Tread

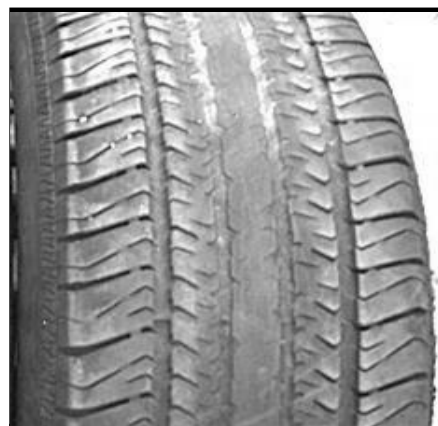
Fast Centerline Wear
